Current state of above-ground and underground structures of the Alexander Column: an integral basis for its stability

Regina E. DASHKO, Angelina G. KARPENKO✉

Empress Catherine II Saint Petersburg Mining University, Saint Petersburg, Russia

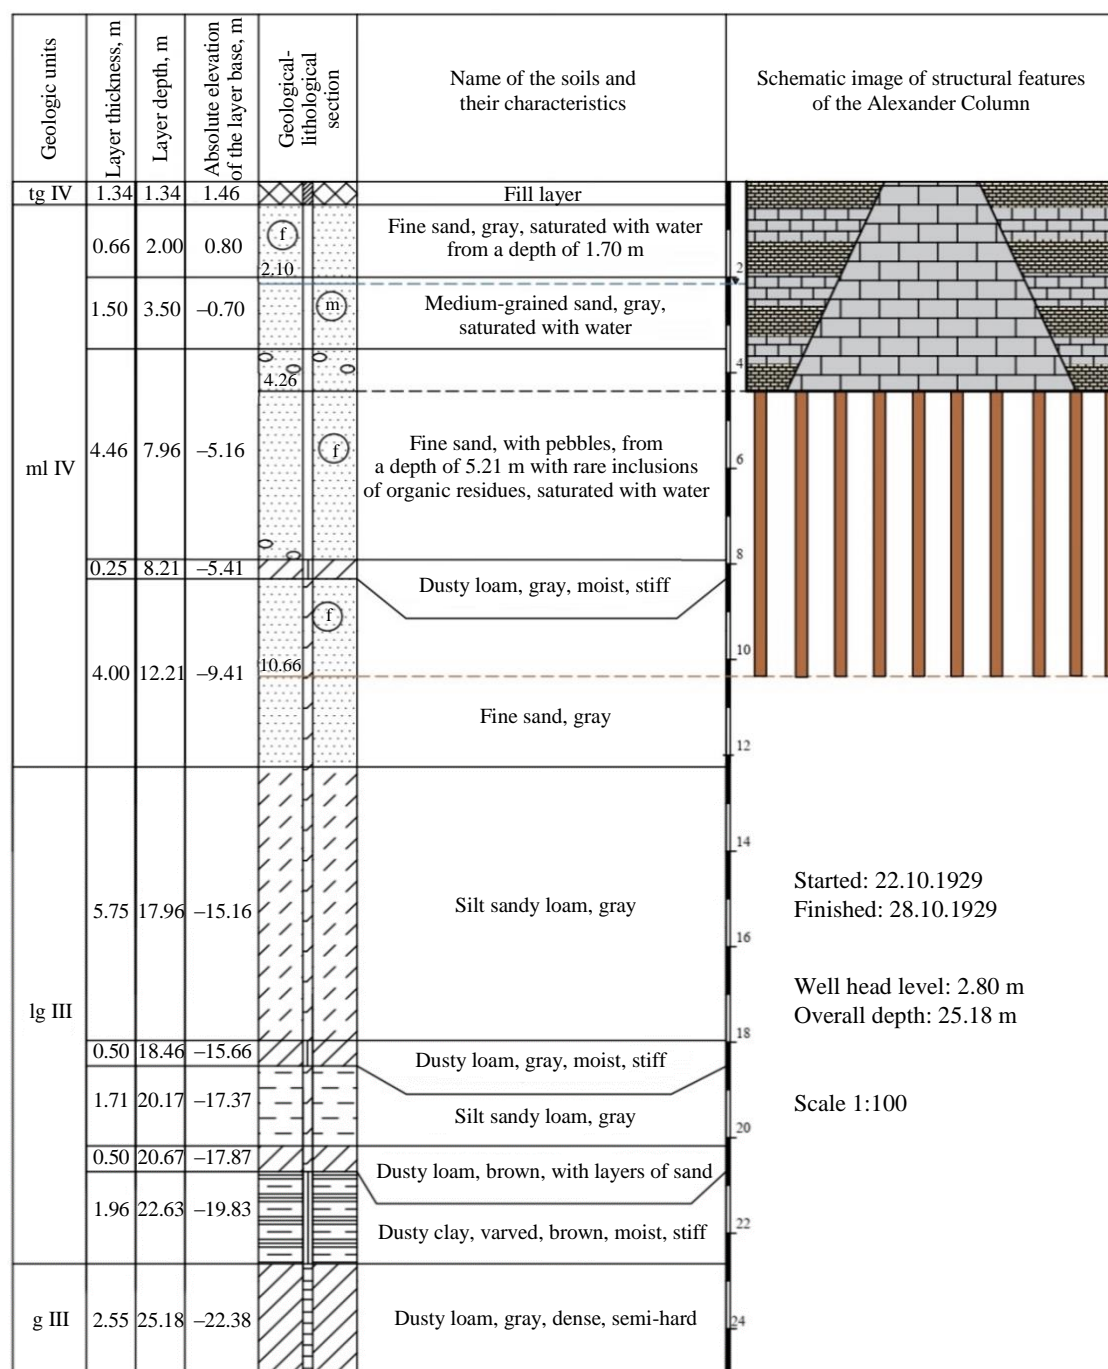
Fig.5. Geological-lithological section of the base of the Alexander Column
(archive data of the Committee for Urban Development and Architecture of St. Petersburg)

From Fig.5, it can be seen that the bearing horizon of the pile foundation of the Alexander’s Column is water-saturated fine-grained gray sands of lacustrine-marine genesis. Below, weak

clayey layers of lacustrine-glacial origin are traced. Studies of the physical and mechanical properties of soils in 1929 were not carried out, since there were no laboratories for engineering-geological study of soils in Russia.

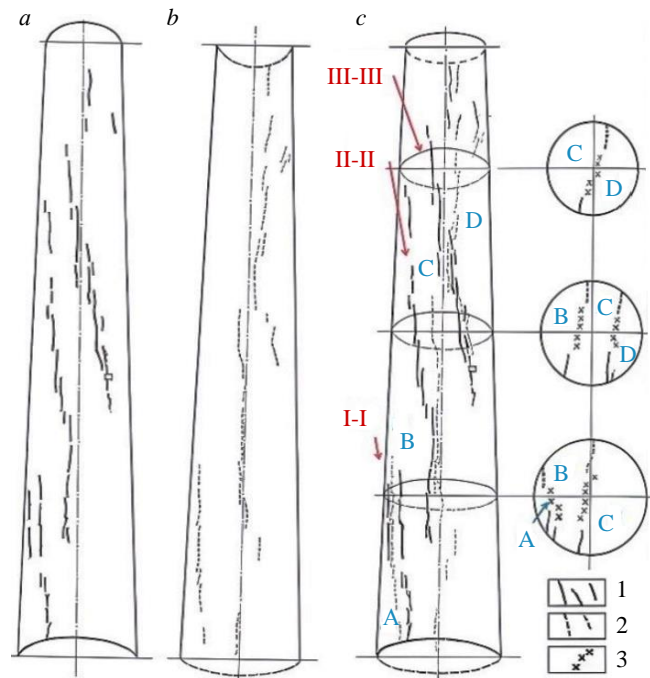
Fig. 7. Scheme of the fracture network of the granite core of the Alexander Column (data from M.A. Ivanov):

Since a monolith for the column was extracted at a depth of 7 m, it experienced almost 20 MPa of horizontal stress that caused subhorizontal tensile microcracks in its rock mass. These microcracks were hard to detect visually. The choice of this place for sampling granite-rapakivi by A. Montferrand was explained by the location of the required monolith between horizontal macrocracks, which predetermined the initial diameter of the column [11]. Such cracks divide the massif into layers, forming the so-called structure of a “layered pie”, according to the terminology of M.A. Ivanov [26].

After the column's monolith was transported from the quarry to Palace Square where it was processed, polished and mounted on a pedestal, the microcracks in its granite shaft took a subvertical direction. Under its own weight, these microcracks transformed into macrodefects. This process was accelerated by additional pressure due to the fragments of the column installed above (see Table 1). Temperature stresses in the polymineral rock, as well as wind loads contribute to the growth of existing and appearance of new cracks in the shaft. The effect of these natural factors on the degradation of granite-rapakivi was described by G.P. Helmersen [19].

In 2021, Professor M.A. Ivanov from St. Petersburg Mining University studied the granite shaft using a binocular and digital imaging. He created a scheme of fracturing for northern and southern parts of the Aleksander column and their combined projection (Fig. 7) [26].

M.A. Ivanov's research showed that only vertical and subvertical tensile cracks that existed in situ in granite-rapakivi massif before extraction continued to develop (Fig. 7).
