Current state of above-ground and underground structures of the Alexander Column: an integral basis for its stability

Regina E. DASHKO, Angelina G. KARPENKO✉

Empress Catherine II Saint Petersburg Mining University, Saint Petersburg, Russia

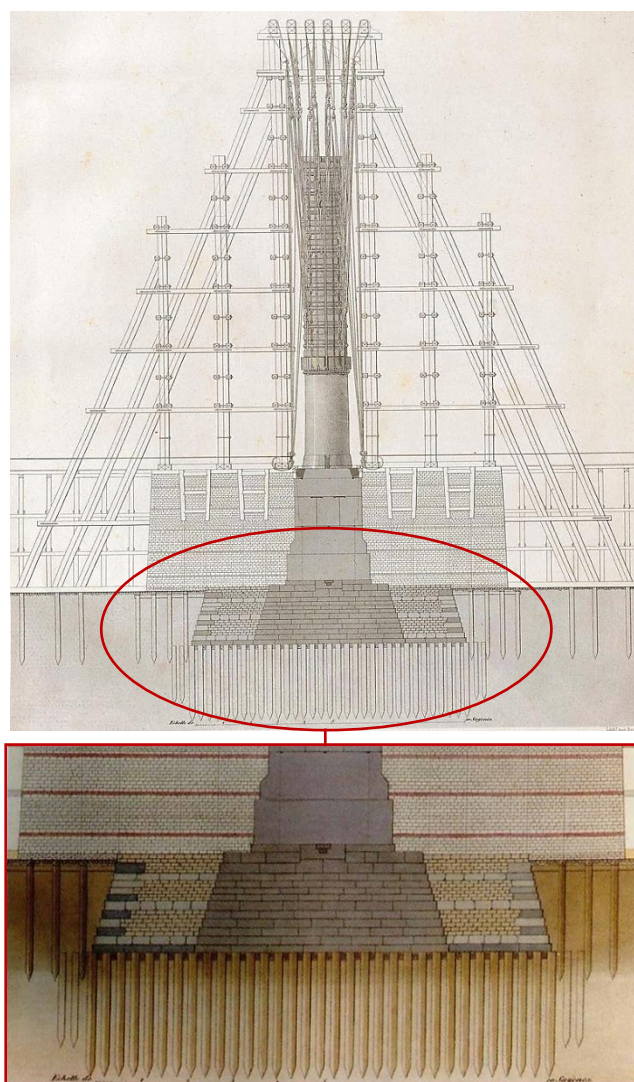
Fig.3. The view of the Alexander Column with underground structures (from albums of A.Montferrand) [10]

weak soils [45, 46]. Thus, it is possible to examine the state of piles, which were driven from ground surface for brick masonry of temporary structures with purpose of installing lifting mechanisms on them for subsequent installation of the shaft (see Fig.3). Examining such a pile along its full length using low-impact methods will provide information about the state of wood – pine below level of contaminated sewage groundwater, as well as identify main taxa of microorganisms from host soils and water. This will enable us to determine the aggressiveness of microbiota towards the construction materials of the monument underground part, their role in transforming dispersed soils and the biochemical composition of groundwater, as well as the development processes of gas formation due to the activity of microorganisms. Developing the concept and content of the monitoring should be considered as a separate topic of research.

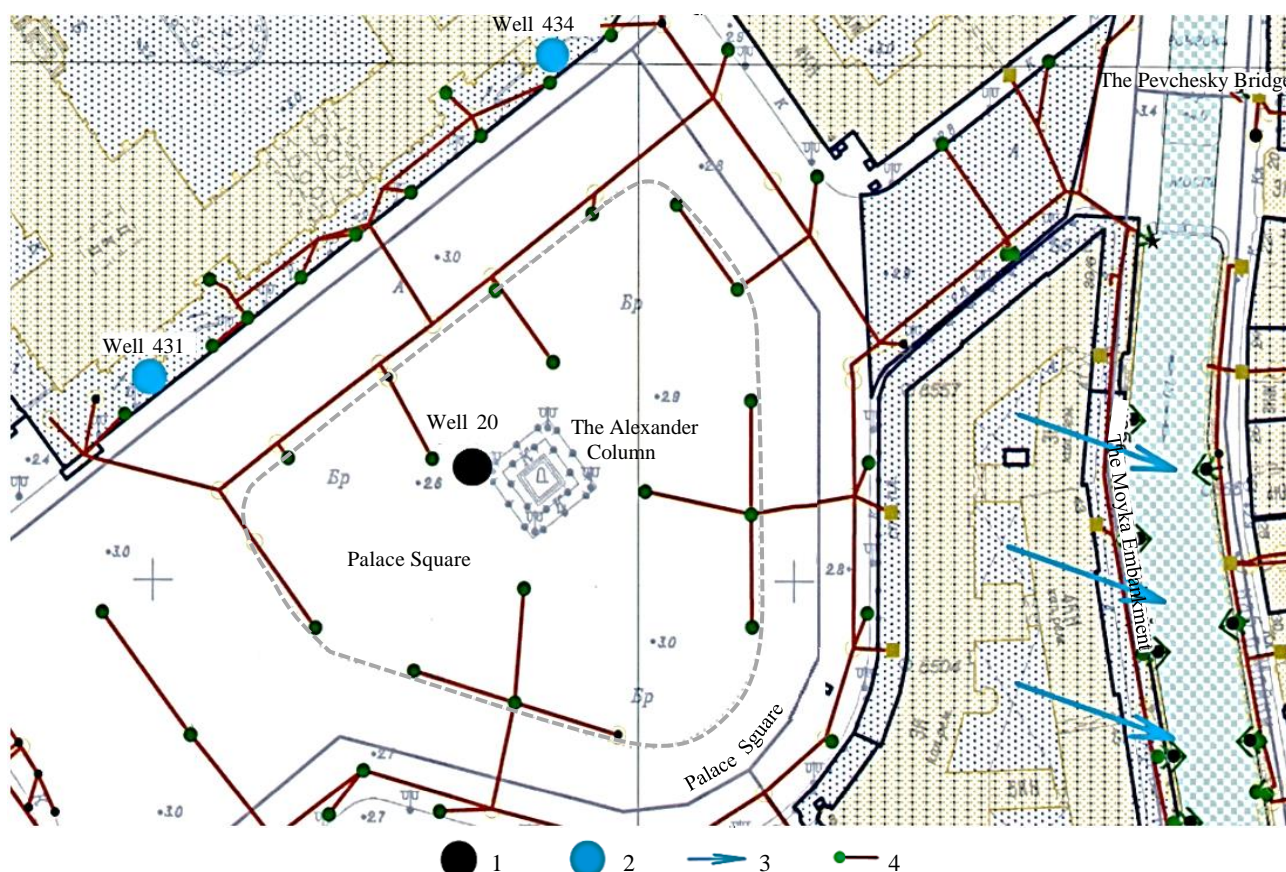
Fig. 4. Layout plan of local sewerage system and geological-hydrogeological wells
 1 – reference geological well; 2 – hydrogeological well; 3 – groundwater discharge direction;
 4 – position of shallowly laid local sewerage system

According to the chemical composition, groundwater within the Palace Square is chloride sodium. High values of mineralization are noted due to the content of potassium and sodium ions, chlorides and sulfates, which indicates contamination of groundwater by leaks from operating sewer systems (see Fig.4). A large amount of calcium and magnesium ions is associated with the dissolution and leaching of alkaline earth elements from underground bearing and enclosing structures of buildings of the Palace complex.

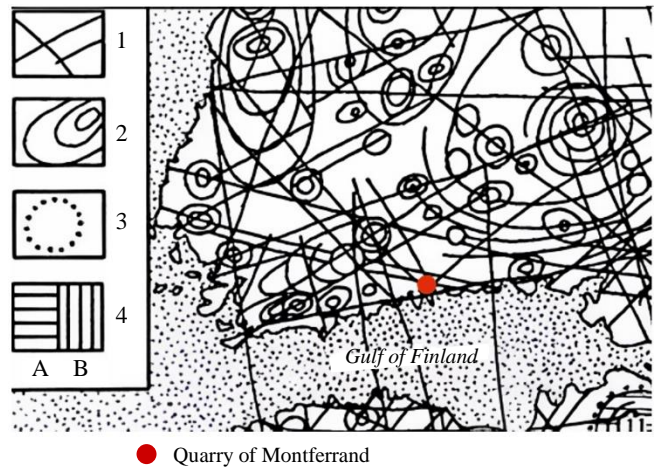
Montferrand’s quarries are located in the southeastern part of Finland. The considered area is associated with anomalous sections of the Fennoscandian Shield (submersion zones) and is characterized by complex structural-tectonic conditions [21], as indicated by the data of the cosmotectonic map (Fig.6) [22].

Fig. 6. Fragment of the cosmotectonic map of the north-west of the Russian Plain [22]
